A Coastal Zone Survey Project as a Tool for CZM Authorities in Rhodes Island

Hellenic Centre for Marine Research (HCMR)

AKTI: Survey in Rhodes Island CZ

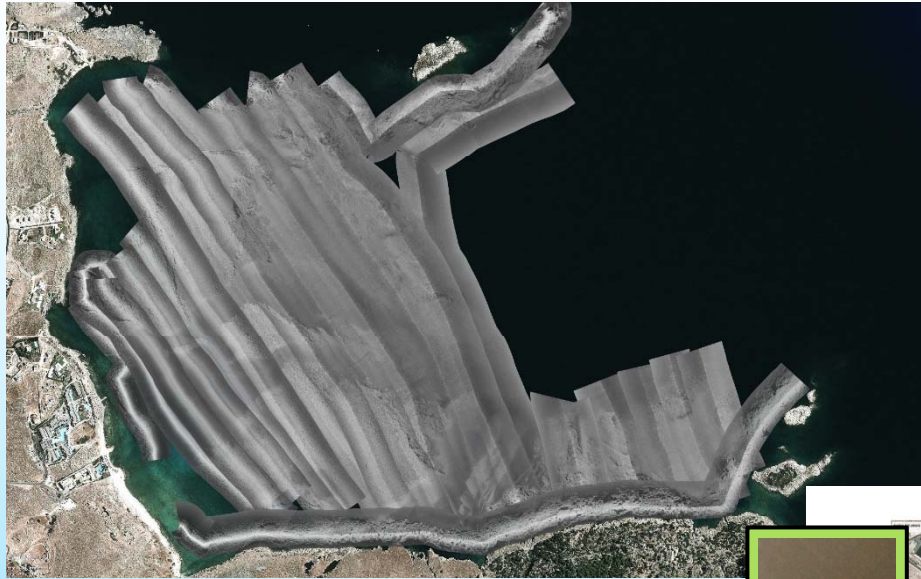
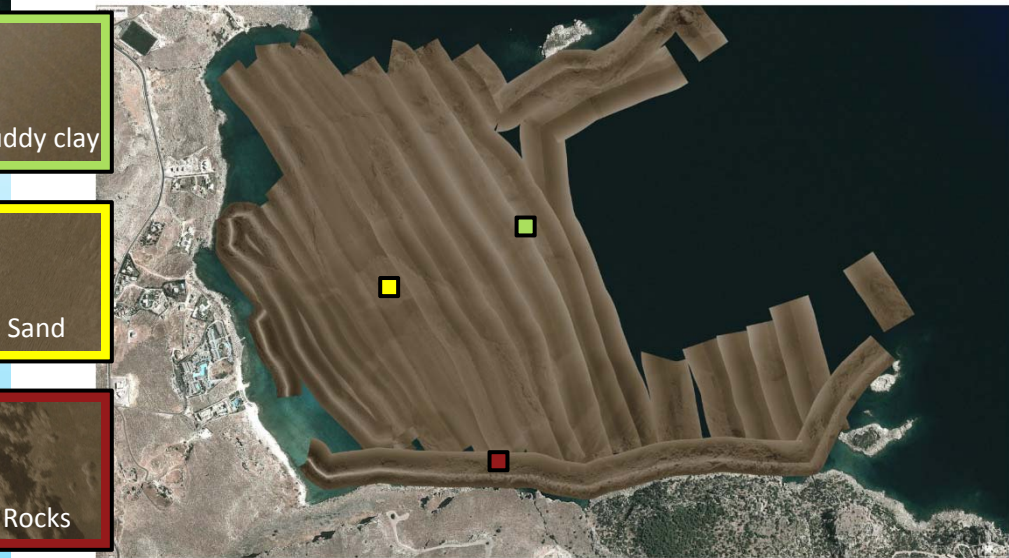
AKTI: Case study for a diving park > Agios Nikolaos Bay, Rhodes > Side-scan sonar survey and sediment sampling

Muddy clay

Sand

Rocks
